Surface Water Test at a Dairy Farm

Gary Walker

GAPS

February 17th, 2022

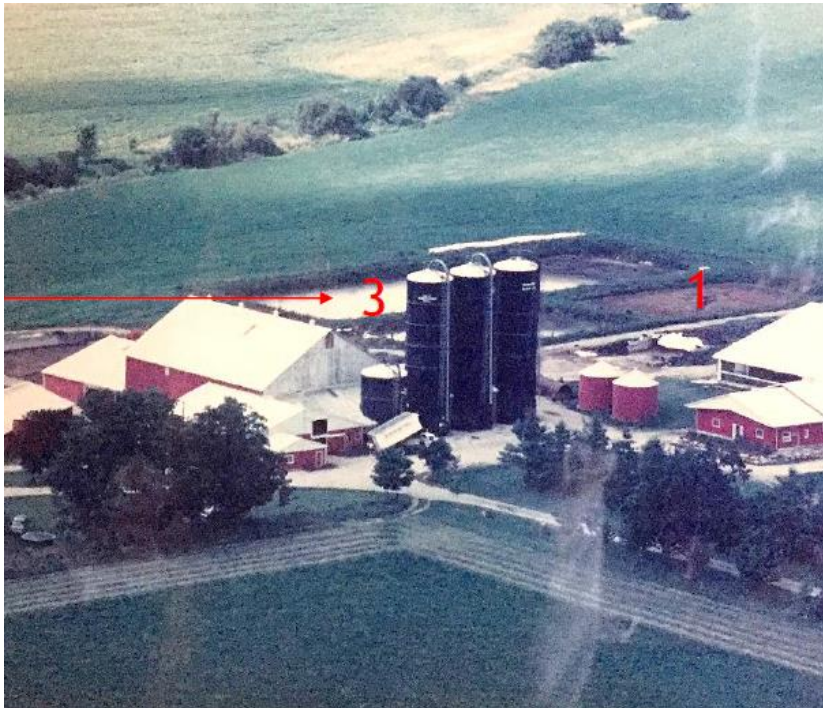
The Set-up

- Outdoor heifer barn area and bunk silo
- A grassed waterway to drain surface water away to a protected Hickenbottom located between the two structures
- **Smart Sponge** impregnated with Fe-oxide to intercept soluble P
 - Leftover supply from Chippewa test
- Direction of flow from above the cement structure
- Water sampling scheduled for next rain event
